ABSTRACT:

In this test report we investigate the two way 2 MHz communications between DIRECTV receivers and SWM switches. Customers have reported error code 771A in some MDU installations resulting in H24 receiver lock-up and grey screens. We replicated the error code and measured the signal levels resulting in the error code.

DIRECTV AIM METER TESTS

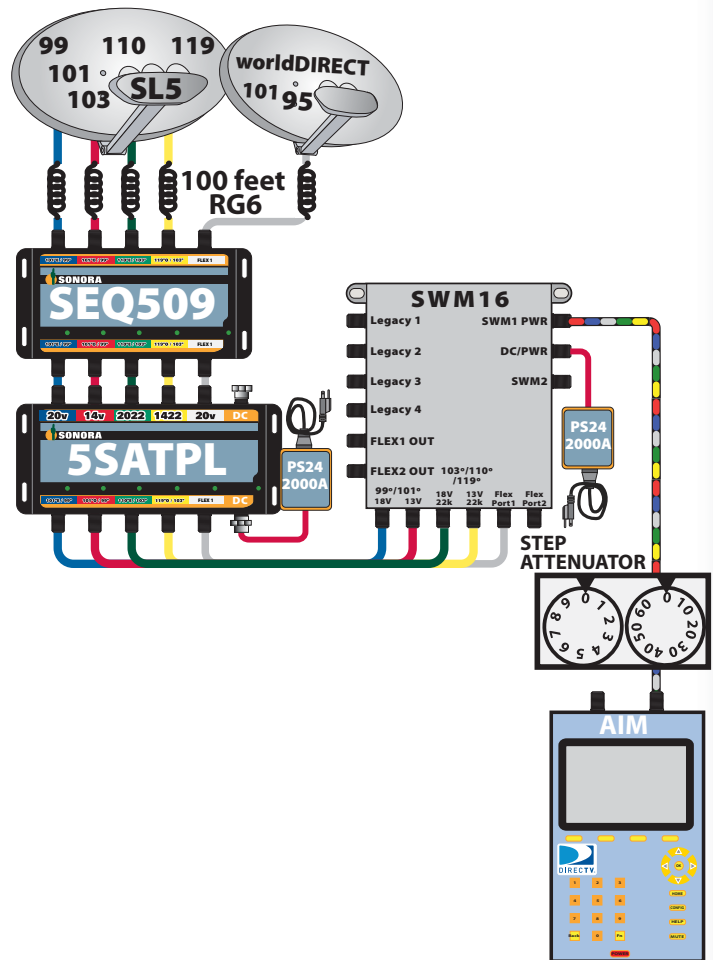
1. An attenuation of **31 dB** resulting in a PASS reading with a measured power level of -34.9 dBm.
2. An attenuation of **32 dB** resulting in a FAIL reading with a measured power level of -35.9 dBm.

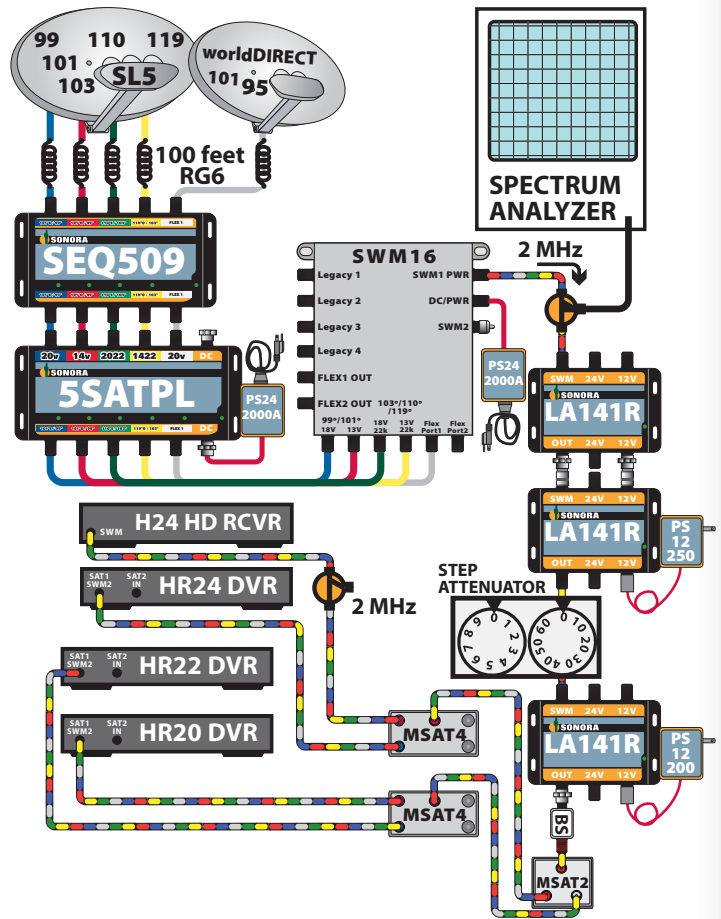
6. The various model receivers may experience the error a different attenuation levels.
7. Note the 2 MHz loss for the system components is as follows: HRT116 = 2.5 dB, LA141R = 2 dB, MSAT-2 = 4 dB, MSAT-4 = 11 dB. Total loss less step attenuator is (2.5+2+2+2+4+11) = 23.5. The HRvT116 tap at the H24 was removed to run the test in step 5. The table below includes the 23.5 dB system loss + attenuator loss.

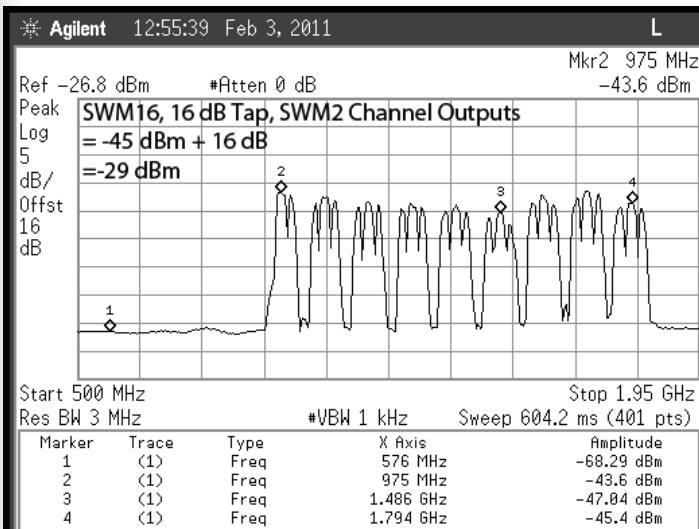
The top plot illustrates the (9) forward SWM channels originating from the SWM2 output port. For this measurement The SWM16 has an output level of -29 dBm.

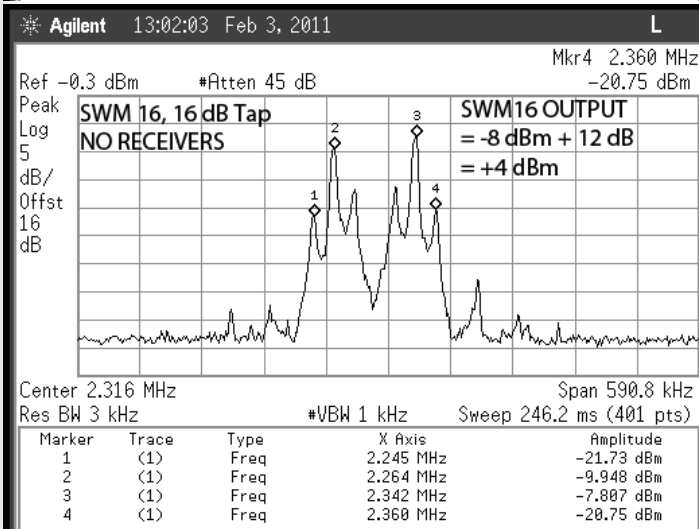
The SW16 generated control signals from 2.25 MHz to 2.36 MHz. ALL receivers were disconnected from the MSAT-4 splitters to prevent their 2 MHz signals from influencing the measurement.

The spectrum analyzer was configured for "Max Hold" to capture the peak levels of the 2 MHz. In real time the signals are jumping up and down indicating a timed signal sequence to receivers.

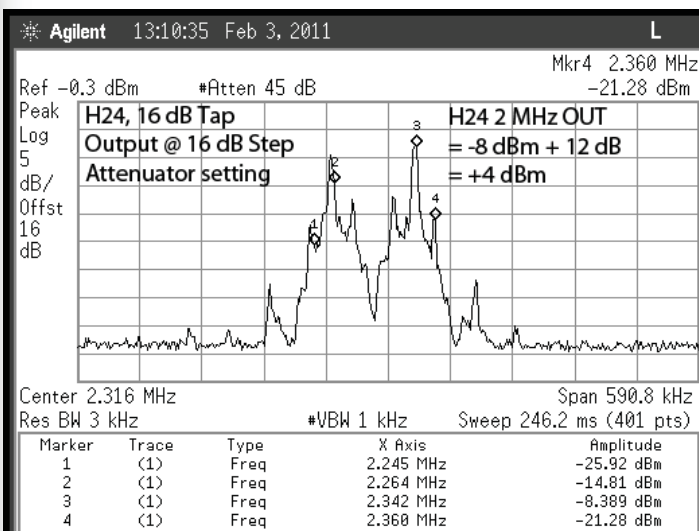
The receivers generate control signals from 2.25 MHz to 2.36 MHz. An in-line 16 dB tap is used to measure the signals without disrupting communication to the SWM16. The tap is directional to allow the tap port to measure the signals from the receiver while rejecting the signals from the SWM16.

The 16 dB tap has a measured 2 MHz tap loss of 12 dB. The calculated H24-700 output is -8 dBm + 12 dB tap loss = +4 dBm.

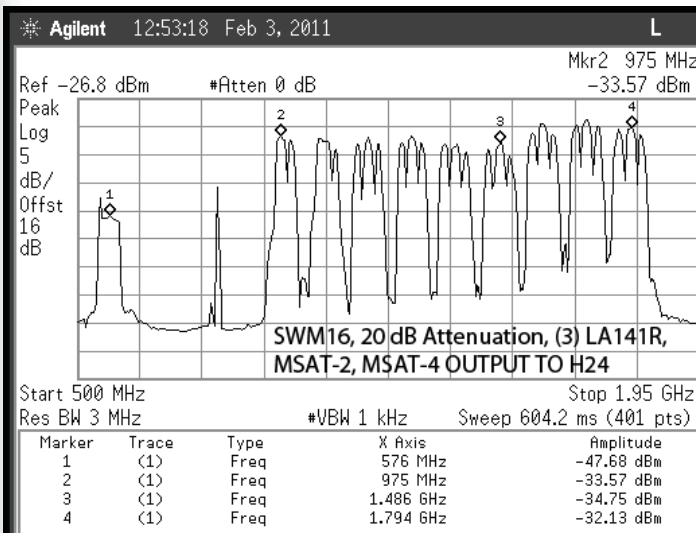
The plot on the left illustrates the SWM channel output from the MSAT-4 splitter when the step attenuator was set to 20 dB. The SWM level was -32 dBm.

ALL receivers worked with 14 dB of step attenuation (37 dB total)

@ 16 dB of step attenuation, the H24 registered error code 771A (39 dB total)

@ 26 dB of step attenuation, the HR22 registered error code 771A (49 dB total)

@ 37 dB of step attenuation, the HR20 registered error code 771A (60 dB total)

@ 40 dB of step attenuation, the HR24 registered error code 771A (63 dB total)

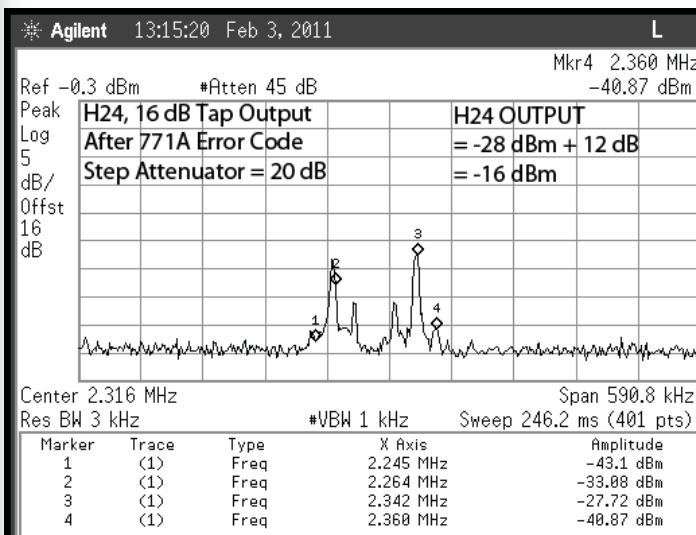
Once the H24 receiver generated error code 771A, it lowered it's 2 MHz output from + 4 dBm to -16 dBm.

Once the 2 MHz attenuation was reduced, the H24 receiver was reset to the full +4 dBm 2 MHz output by disconnecting and reconnecting the drop cable.
